CLINICAL DEVICE-RELATED ARTICLE

In vivo corrosion and damages in modular shoulder prostheses

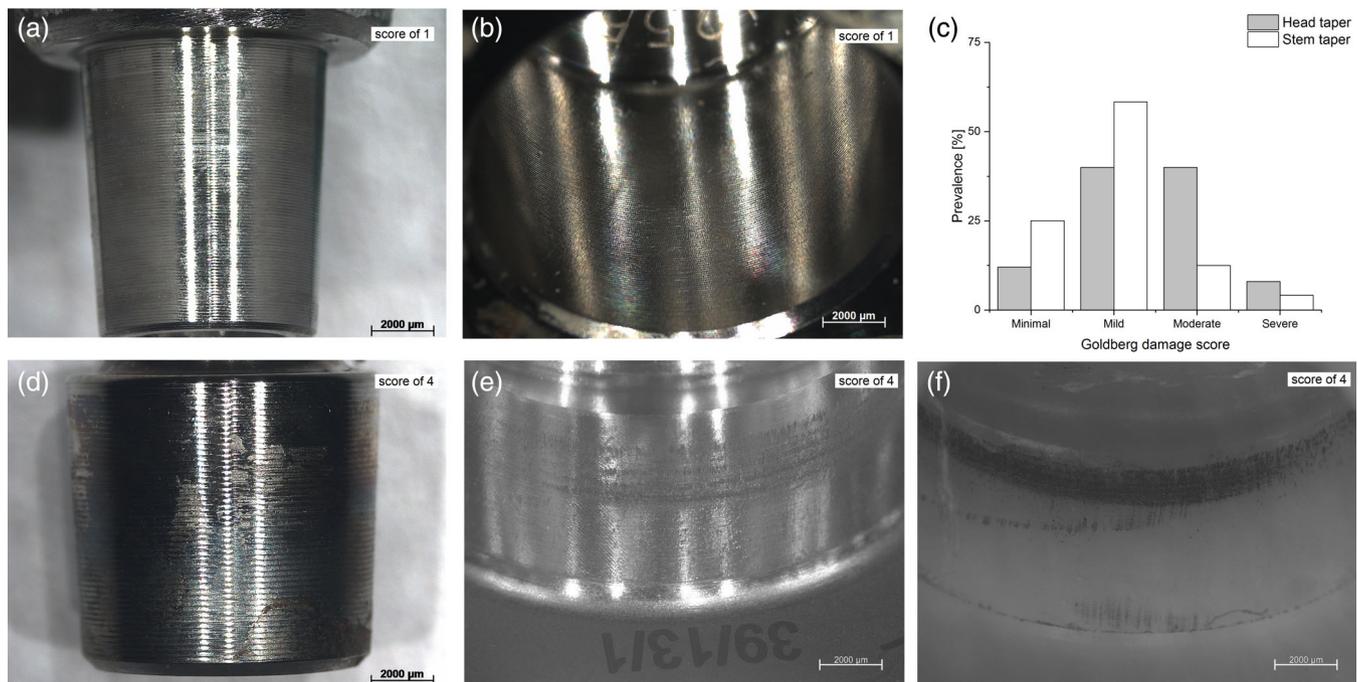
The consecutive cohort of 35 anatomical shoulder retrievals was evaluated according to the modified Goldberg score. The graded damage scores are shown in Figure 1c. Fretting and corrosion (Score ≥ 2) were detected on 31 (89%) head tapers and 26 (74%) stem tapers with a small difference in their average damage score (2.4 ± 0.8 , 2 ± 0.8 , respectively). Head tapers exhibited more serious tribocorrosion (Score ≥ 3) with 17 cases than stem tapers with only 6, whereas severe damage (Score ≥ 4) was present on 3 heads and 2 stem tapers. Representative images of minimally and severely affected head and stem tapers are shown in Figure 1. Damage patterns have been observed in all material couplings of head and stem tapers.

FIGURE 1 Representative images of a stem and head taper with different damage scores. Minimal taper damage (score of 1) of a (a) CoCrMo wrought alloy stem and (b) CoCrMo wrought alloy head taper and severe taper damage (score of 4) of a (d) TiAlV stem taper, (e) CoCrMo cast alloy head and (f) ceramic head taper. (c) Comparison of the incidence rate of damage scores on the assessed head and stem tapers of the retrieval cohort

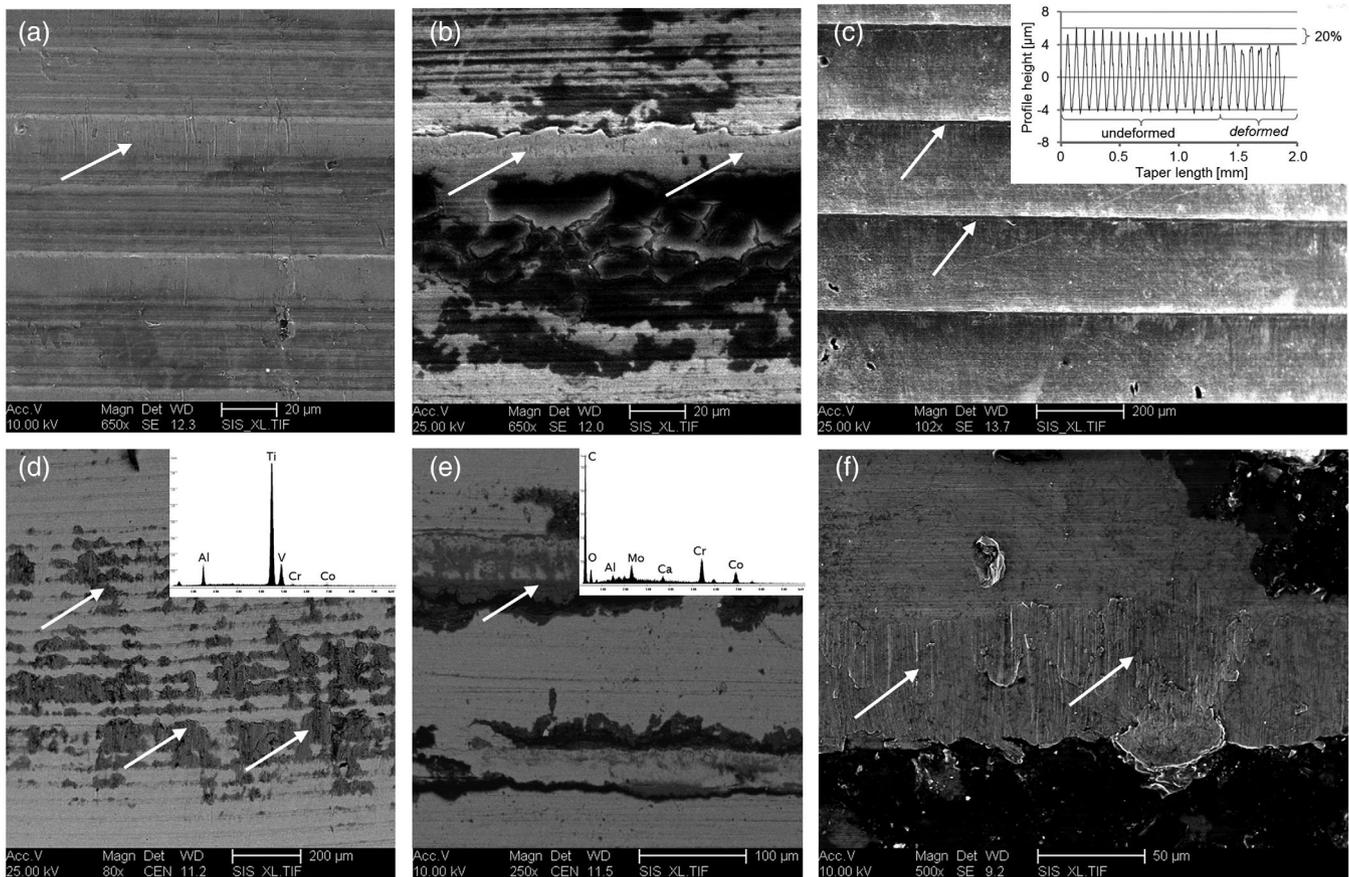
by the joining, in vivo loading and disassembly processes. The plastic flattening process is present on all stems independent of the surface finish or alloy composition (Figure 4a,b). The flattened machining peaks deformed approximately by 20% of the maximum peak height as illustrates in the tactile measured height profile of an exemplary TiAlV alloy stem (Figure 4c). In addition, some deformed peaks were covered with linear grooves in axial direction (Figure 4a) that demonstrate abrasive microploughing. This overlapping mechanism of plastic deformed machining marks with deep linear grooves was mainly present on tapers with a mixed CoCrMo/TiAlV alloy combination.

Besides the plastic deformation, there is evidence of *adhesive material transfer* and related cohesive material defects from the stem to the head taper and vice versa. Different grey-scales in the backscattered electron contrast images (CEN detector) distinguish the disparate alloy distribution. Figure 4d illustrates a case in which the CoCrMo alloy head taper is covered by adhering residues of the TiAlV alloy stem (Figure 4d) and corresponding surface breakouts on the TiAlV alloy stem (Figure 4f). Besides titanium, the adhering material

FIGURE 4 Scanning electron microscope (SEM) images that demonstrate plastically deformed machining marks and backscattered electron contrast images (CEN detector) with adhering material residues of different taper surfaces. (a) Widespread compressed bands characterize deformed machining peaks on a CoCrMo alloy head aligned with a TiAlV alloy stem. (b) Flattened machining marks with deformed edges on a CoCrMo alloy stem coupled with a CoCrMo alloy humeral head. (c) Roughness profile section of a tactile measurement on a TiAlV alloy stem showing the transition from an unloaded to a plastically deformed section. The maximum peak height is deformed by ~20%. (d) CoCrMo alloy head taper with extensive TiAlV alloy flakes (dark areas) that have been transferred from the stem taper. The EDS spectrum verifies the elements of a TiAlV alloy. (e) TiAlV alloy stem taper of a CoCrMo/TiAlV couple with accumulated organic residues as well as chromium and molybdenum oxides at the flattened machining marks. Besides the occurrence of adhesion there is an accumulation of corrosion products observable. (f) SEM image of characteristic material breakouts on a TiAlV alloy stem taper

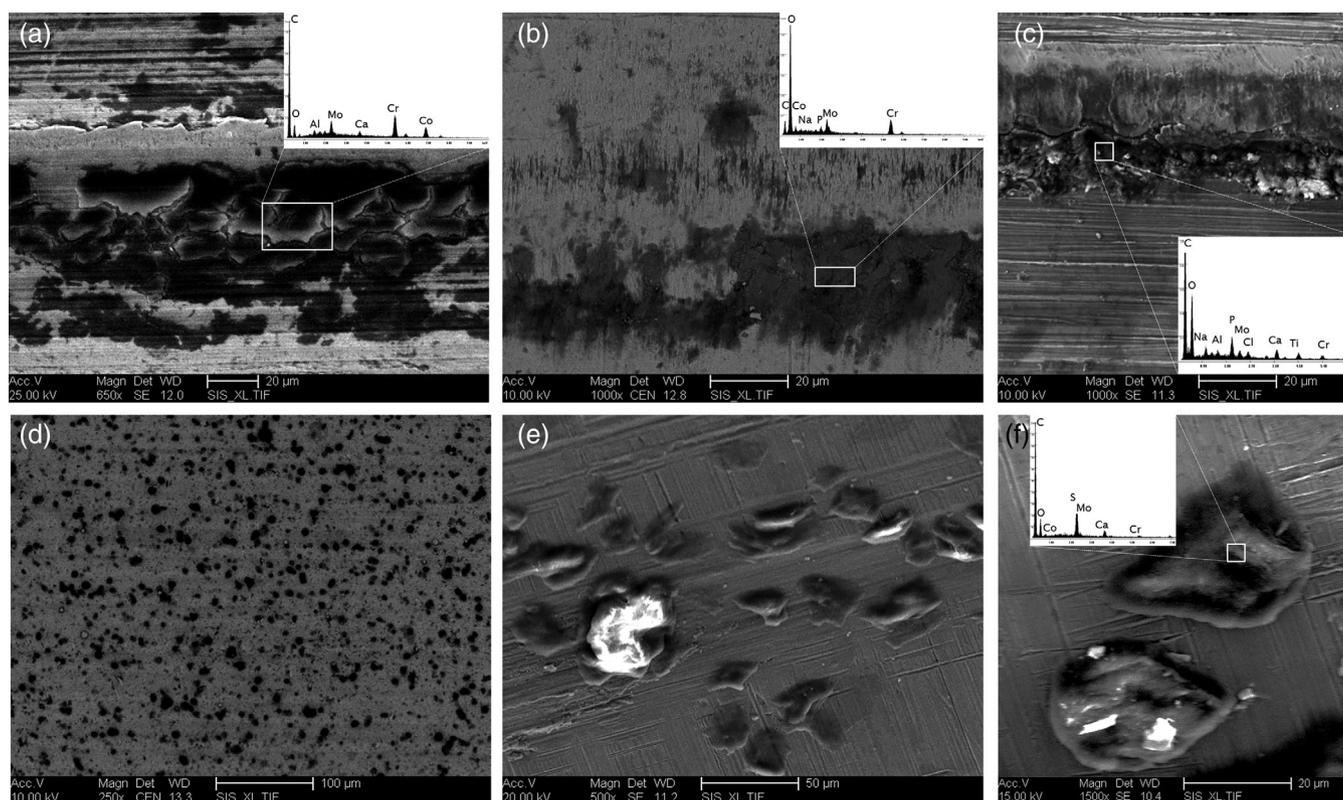
Besides the adhesive material transfer, there are examples of thick *deposits*, *tribological film formation*, and *organic residues* in the troughs of the machining marks on almost all stem and head tapers. In most cases, the EDS spectra revealed strong carbon, oxygen as well as molybdenum and chromium peaks (Figure 5a). Some cases were found with a peak of phosphorus and chromium oxide indicating the occurrence of chrome phosphates (Figure 5b,c). This carbonaceous adhesive layer was present on all material combinations as

Another observable phenomenon was the occurrence of separate organic residues that resembled cell-like structure such as macrophages regarding size and morphology. These visually resembling *adhering cells* were detected on CoCrMo alloy head tapers as well as on TiAlV alloy stems (Figure 5e,f). Their presence was more pronounced in distal taper regions outside the clamping area. Higher magnifications did not show any defect marks that may be associated with them.

FIGURE 5 Scanning electron microscope (SEM) images of adhering tribological films, deposits and cell-shaped residues that resemble macrophages. The white frames indicate the area of the depicted energy dispersive X-ray spectroscopy (EDS) spectrum (a) SEM image of a CoCrMo/CoCrMo coupled stem taper with accumulated deposits within the machining troughs. The EDS spectrum shows high peaks of carbon, molybdenum and chromium and a lower peak of cobalt. (b) CoCrMo stem taper with a tribological layer that consists of a mixture of carbon, molybdenum, chromium, and phosphorus. (c) CoCrMo/TiAlV coupled stem taper with accumulated oxide deposits. EDS spectrum shows the occurrence of chromium and molybdenum oxide as well as some low signals of the TiAlV alloy. (d) Round shaped remnant on a CoCrMo alloy head taper that was combined with a TiAlV stem. (e) Cell-like adhesive residues on a TiAlV taper adapter in an area outside the clamping range. The adapter was coupled with a CoCrMo humeral head. (f) CoCrMo alloy head taper that was aligned with a TiAlV alloy stem shows adhering cell-shaped residues

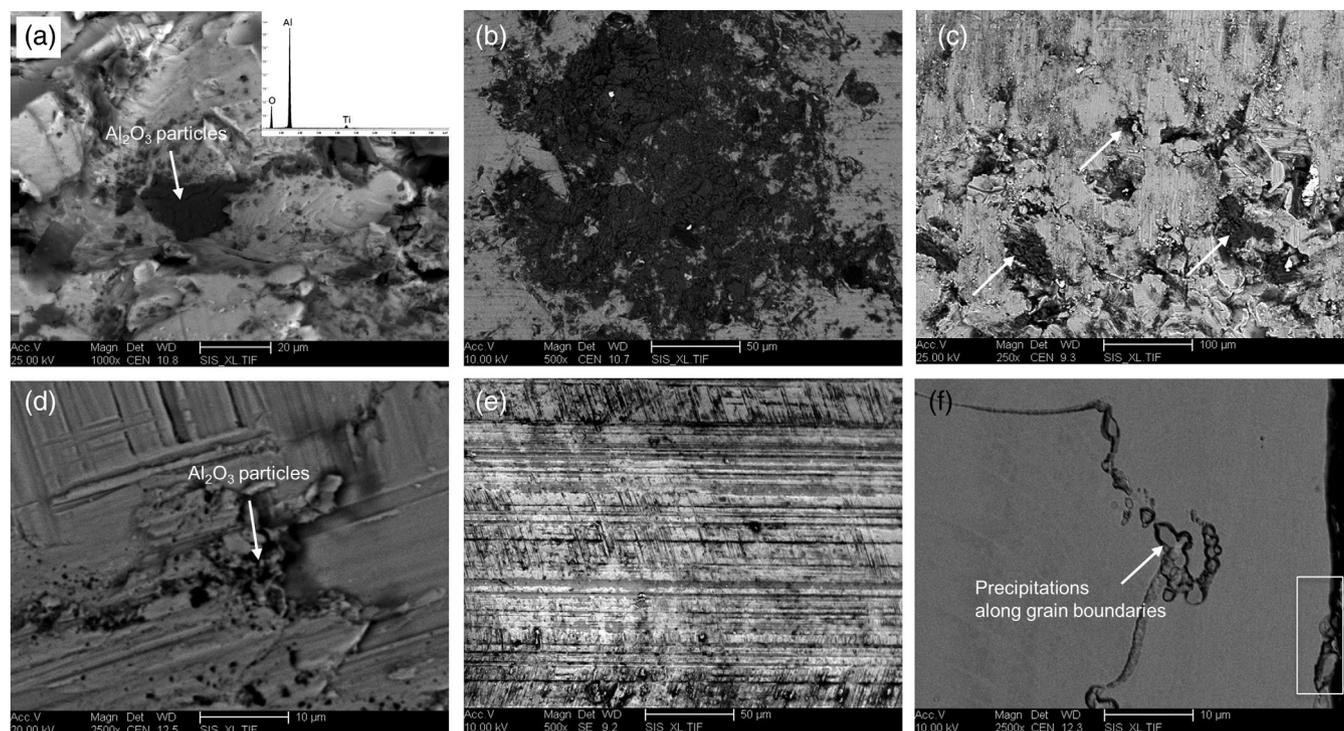
Particle-induced *microploughing* was identified as a separate damage type that mainly occurred on CoCrMo alloy head tapers in combination with corundum blasted stem tapers (Figure 6). The particles adhered to the aligned counter body and produced abrasive scratches in the CoCrMo head taper (Figure 6d). EDS spectra of different spot scans verified the presence of corundum particles at the top of the scratch marks.

FIGURE 6 Scanning electron microscope (SEM) images of particle-induced microploughing. (a) Backscattered electron contrast image of a TiAlV/CoCrMo combined stem taper with evidence of corundum particles embedded at the surface of the clamping area. (b) TiAlV alloy taper adapter with a large area of corundum grains pressed in the taper surface. (c) TiAlV stem taper with a plastically deformed clamping area. Backscattered electron contrast displayed embedded corundum particles and their scratches. (d) CoCrMo head taper showing adhering particles that generate scratches. EDS spectra identified the dark spots as increased aluminum and oxygen peaks. (e) SEM image of (D) with a lower magnification that shows extensive scratches in all flattened machining marks due to a corundum blasted counter surface. (f) Cross section of a CoCrMo cast alloy head taper that was aligned with a corundum blasted TiAlV stem taper. Residues of corundum particles are pressed into the head taper surface (white frame)

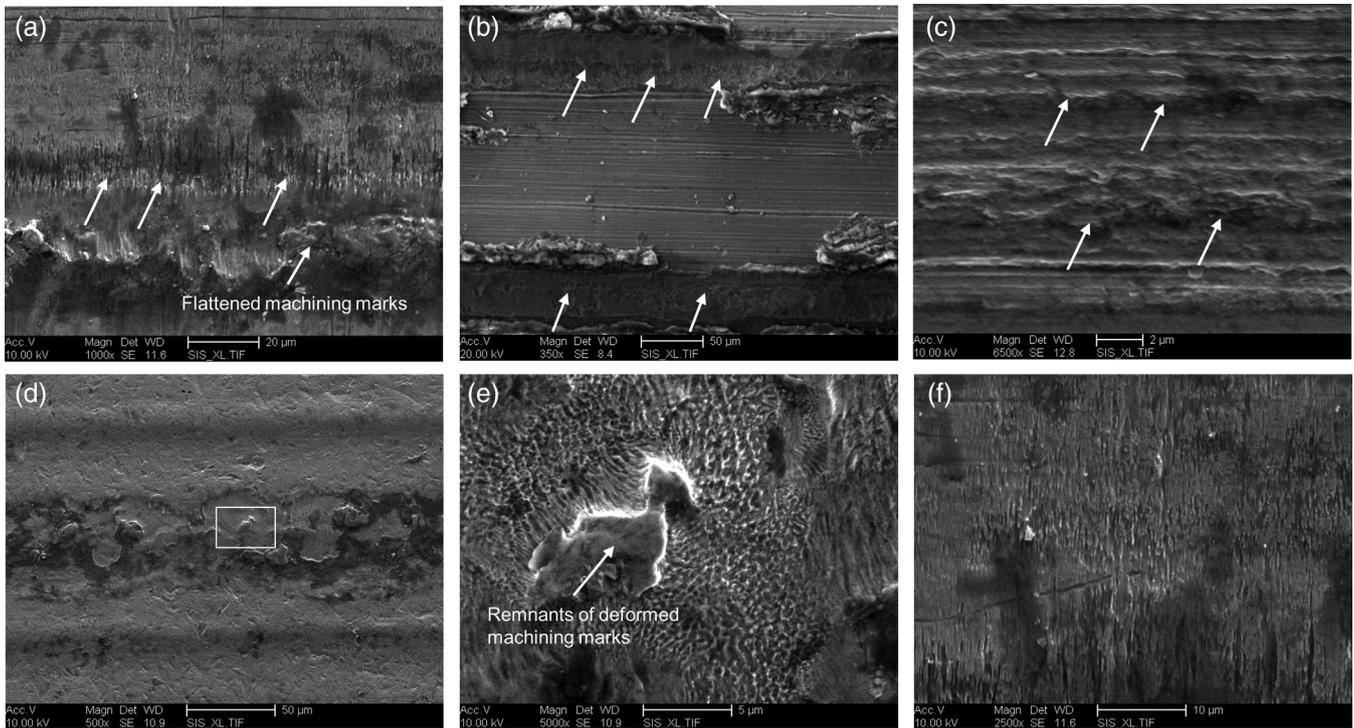
damages were either mechanically or electrochemically dominated. Mechanically induced fretting was observed as fine, parallel arranged scratches next to flattened machining marks in axial orientation to the taper axis (Figure 7a–c,f). Typical features for fretting corrosion (Figure 7d,e) are etching patterns of elongated pits close to remnants of load-bearing deformed machining marks. Mechanical as well as electrochemical fretting occurred separately or combined. The incidence for fretting on head tapers is slightly elevated in mixed CoCrMo/TiAlV couples than in similar CoCrMo/CoCrMo couples with 31 and 20%, respectively. This difference is also present in the corresponding stem tapers with incidence rates of 20% for mixed and 17% for similar taper combinations. Moreover, mechanically dominated fretting was more dominant on CoCrMo wrought alloy and electrochemical fretting with etching marks only appeared on CoCrMo cast alloy.

FIGURE 7 Damage features indicative for mechanically dominated fretting and fretting corrosion. (a) CoCrMo wrought alloy head taper of a CoCrMo/CoCrMo combination with characteristic fretting marks in axial orientation to the taper axis (white arrows) adjacent to the flattened machining ridge. (b) SEM image of a TiAlIV stem taper that exhibits elongated fretting pits at the edge of the deformed machining marks that are indicated by white arrows. The TiAlIV stem was aligned with a CoCrMo head taper. (c) TiAlIV stem taper with disrupted machining marks (white arrows) and evidence of mechanical fretting. (d) SEM image of a CoCrMo cast alloy head taper that illustrates a horizontal area of electrochemically dominated fretting marks. (e) A higher magnification of (d) white frame) displays the presence of strong etching patterns as well as elongated pits that are typical for corrosive damage. In the middle of the image are remnants of the deformed machining peaks. (f) Corrosion pattern on a CoCrMo head taper that evidences planar metal degradation with axial scratches. All SEM images show the tapers oriented from proximal to distal direction
