**Moving Towards Self-Reliance: Living Conditions of Refugee Camps in
Lebanon and Opportunities for Development**

A Thesis

In Partial Fulfillment
of the Requirement for the Degree of
Master of Science in Architecture

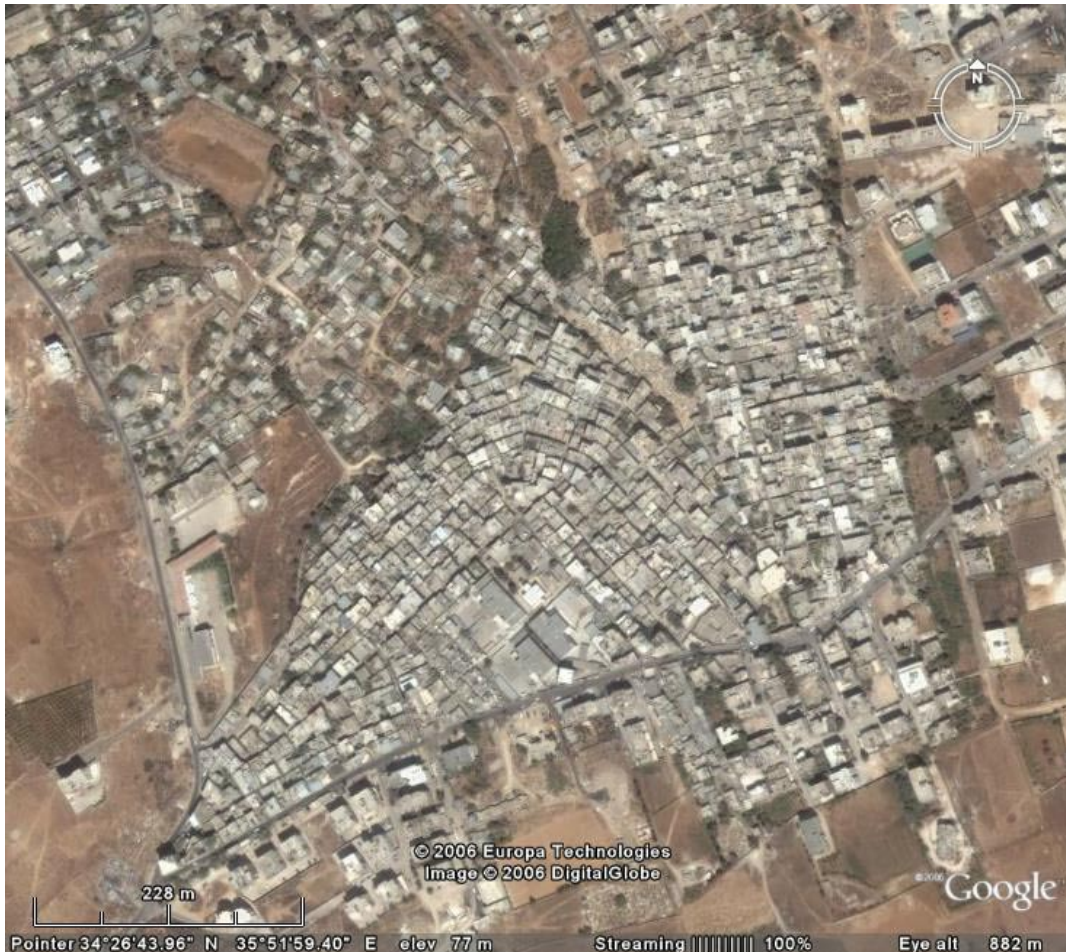
Figure 2.2: Aerial photograph of Al-Beddawi camp

Most camp inhabitants of the Beddawi camp are Palestinians with the exception of a few Lebanese families. The camp appears to be the most spacious in Lebanon. The streets are arranged in a grid formation and all roads appear to be wide enough for two lanes of traffic. The highly organized structure of the camp is probably due to the fact that it was not constructed until 1955 and UNRWA would have been involved in the planning process. The

small homes with poorly furnished rooms have uneven floors, unpainted or cracked concrete walls and roofs, some of which are made of metal sheeting (www.refugeesinternational.org).

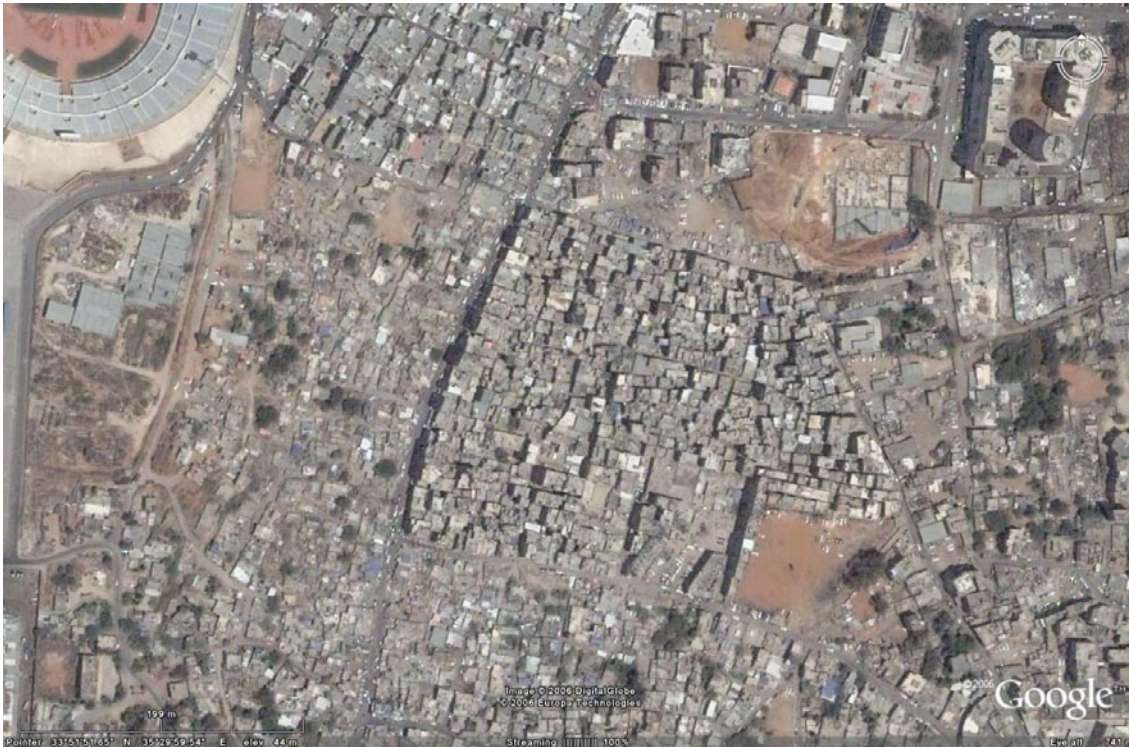
Figure 2.4: Aerial photograph of Shatila camp

Located in a poor neighborhood in Beirut, it is estimated that today, half the population of Shatila is non-Palestinians. According to UNRWA Shatila faces some of the worst environmental health conditions among Palestinian refugee camps in Lebanon, with only three square meter per capita, the camp is overcrowded, the sewage system is inadequate to serve the large number of inhabitants, and with open sewage drains and a unreliable drinking water distributed by the municipality of Beirut the health hazard is very high. Additionally, some of the shelters around the camp are some of the worst among the official refugee camps in Lebanon. In a site visit to the camp, Roberts notes that the shelters appear to be made out of concrete slabs with pieces of cardboard, corrugated steel and plastic sheets for walls (Roberts 2000:31).

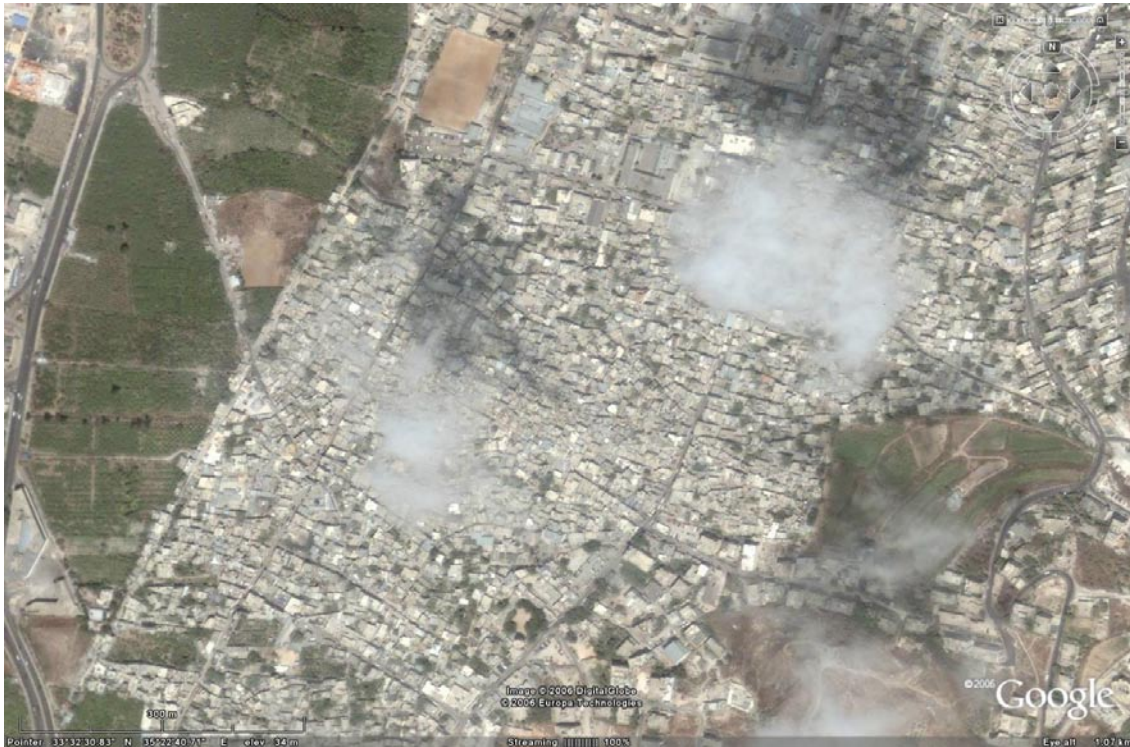
Figure 2.7: Aerial photograph of Ein Al-Hilweh camp

Shelters are small and very close to each other. Some still have zinc sheet roofing. UNRWA constructed a multi-story housing complex in 1993-1994 to accommodate 118 displaced families mainly from Nabatieh camp, which was destroyed during 1973 by Israeli military action. A number of displaced refugees continue to live on the edge of the camp in extremely poor conditions.

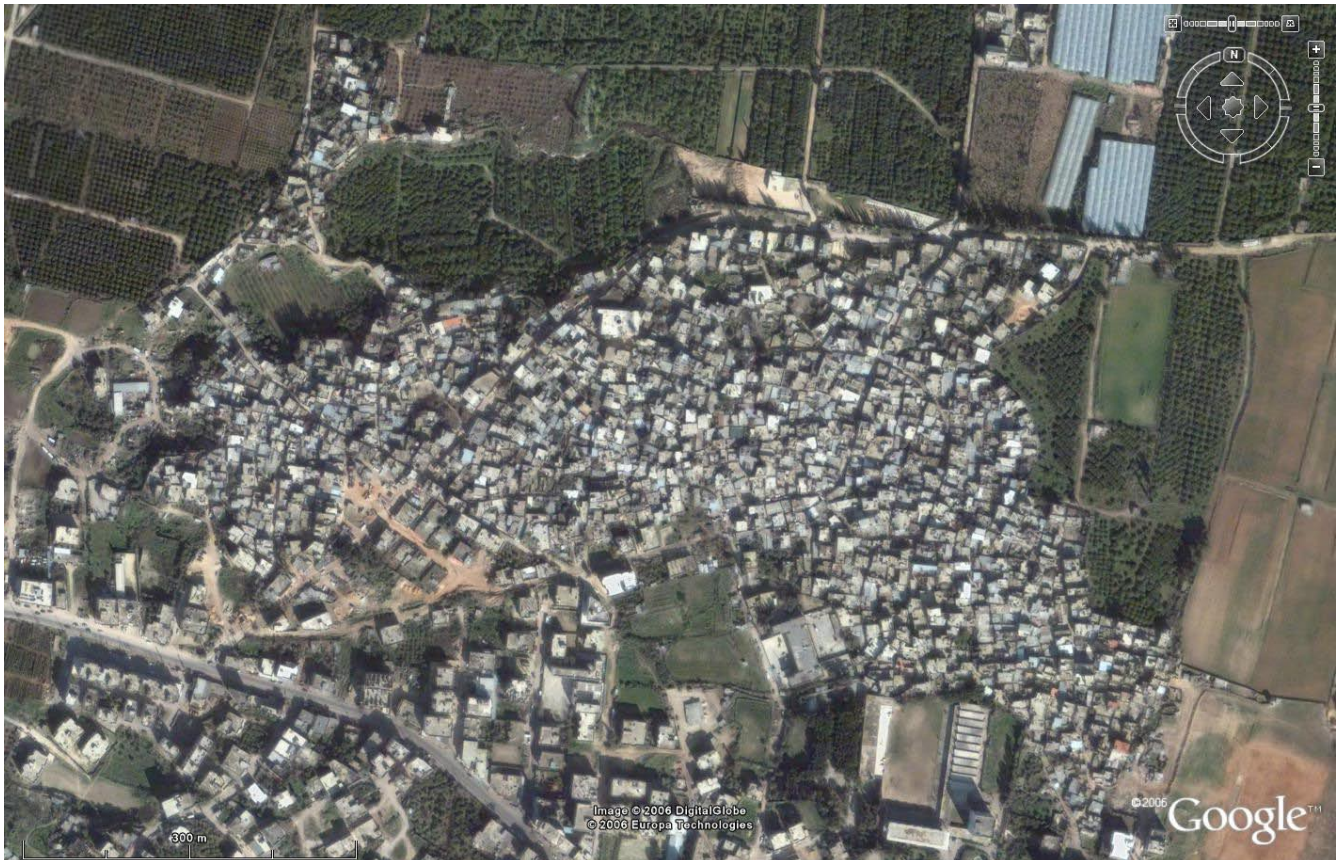
Figure 2.10: Aerial photograph of Bourj Al-Shamali camp

Bourj al-Shamali is spacious in comparison with Bourj al-Barajneh. Most of the camp is accessible by car and many houses have courtyards or small gardens. Despite availability of more space, natural light, and good ventilation in the camp, many houses are small, dark, and stuffy and often in a poorer state of repair than in Bourj al-Barajneh (Roberts 2003). All shelters are supplied with electricity. Water is supplied from three wells operated by UNRWA. In addition, all shelters have private toilets connected to percolating pits. Nevertheless, there are many problems with the infrastructure and sewage and waste water run into open storm run-off drains along roads and pathways.

Because of the ban on building materials, and the fact that few of the inhabitants seem to have the money to undertake repairs or improve their homes, many of the homes still have zinc roofs and bare concrete floors. Zinc roofs are often held in place with large stones and tires. By contrast, there are several houses in the camp that are palatial in appearance.

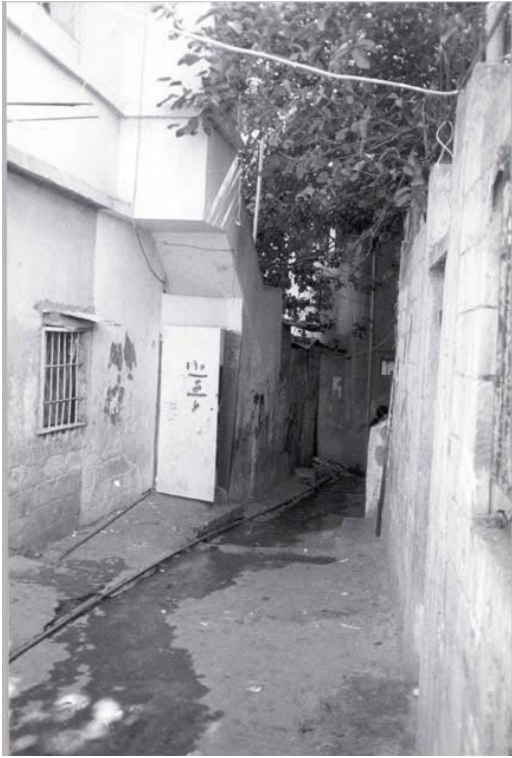
Figure 3.1: Water pipes in the right of way in Mar Elias.

Overall access to safe drinking water and piped water is lacking in Burj El Barajneh and the vast majority of households have no water filtering devices. There are no statistics in this regard that are exclusive to Burj El Barajneh. However, a survey conducted by FAFO of all camps shows that 64% of households have water piped into the residence and 50% have piped drinking water. It is also important to note that the reliability of both piped general use water and drinking water is only a little over 50%.

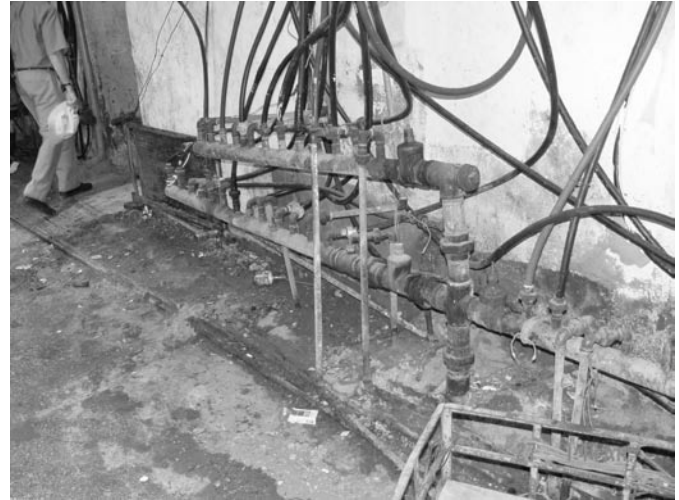
Figure 3.2: Water pipe connections to main- Burj El Barajneh

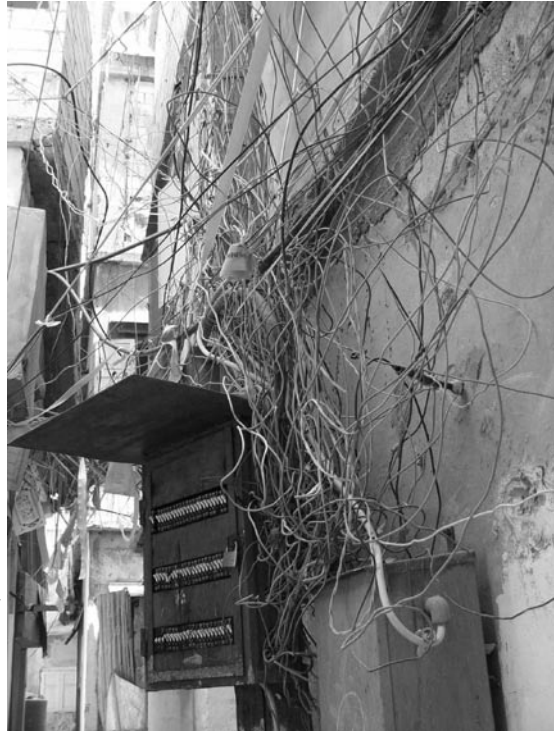
Figure 3.3: Electrical wires tapping into a power main- Burj El Barajneh

Almost all households are connected to an electric network, with various degrees of legality. There are two providers of electricity in the camp, the Lebanese government provides less than half of the households with electricity, while multiple providers service the majority. The main problem with electricity seems to be its poor reliability. Most households have daily power cuts and there does not appear to be any regular schedule indicating when the power outage might occur.

Another problem is that camp inhabitants often tap into an electricity supply outside the camp. Several years ago, the Government realized that it would be impossible to prevent this practice and began charging Palestinians in some camps a nominal fee. A few households have meters and pay for the amount of electricity used. However, the state owned electricity company only collects around 40% of its potential revenue because of infrastructure problems (EIU, 2000:15).

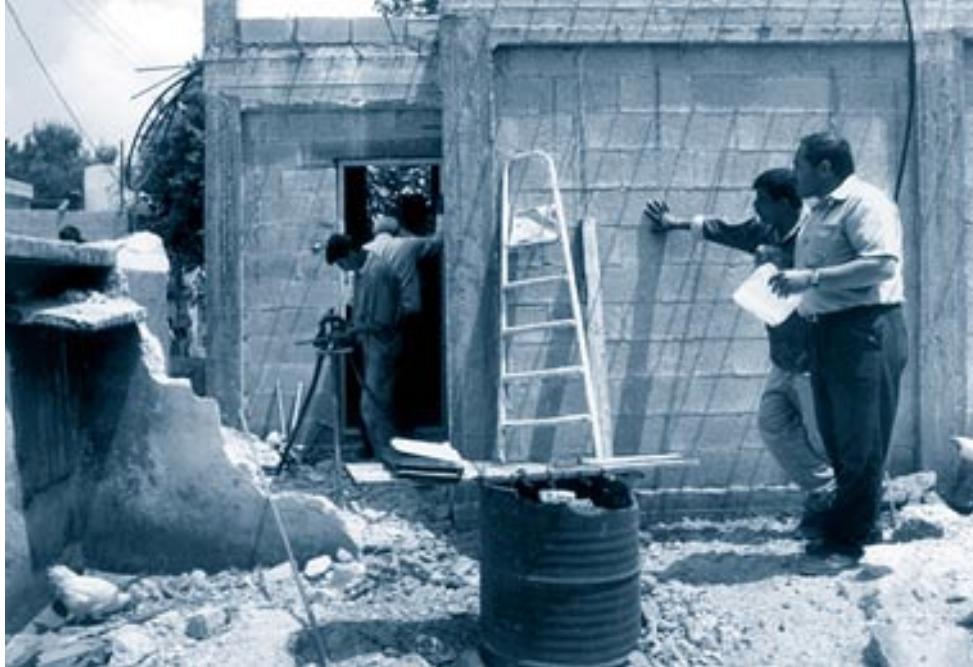
Figure 4.1: Building system used by UNRWA. UNRWA Shelter Rehabilitation Program – UNRWA website

Many of the indoor environment problems in Burj El Barajneh that were discussed previously are symptoms of the lack of good thermal and moisture insulation in shelter envelopes, and insufficient ventilation and daylighting of the shelters. The analysis of structures shows that they are typically constructed using a system of poured-in-place concrete columns. Floor slabs are poured in place as well and in most cases so is the roof slab. Otherwise the roof is typically constructed of corrugated steel panels supported on wood rafters and held down by weights. Concrete blocks are typically used for the walls and in many cases left untreated, or finished with cement plaster coat. As mentioned earlier these blocks offer a physical barrier but perform poorly in providing environmental control. Since the structures of some of the buildings are sound or stabilized by surrounding structures (Figure 4.3), the retrofitting of these structures will be less labor intensive and easier to manage than reconstruction. Given the current condition of the buildings in the camp, the envelope can theoretically be removed and replaced by an alternative wall system, without jeopardizing the stability of the dwelling itself or the surrounding buildings. This can be achieved by the replacement of the existing concrete block walls with an alternative wall system of panels or blocks. Naturally, a different treatment will need to be developed for dealing with the thermal insulation of the floor and roof slabs, since they are both an integral part of the structure. The following section discusses the different parts of the buildings and the possibilities for the treatment of each part:

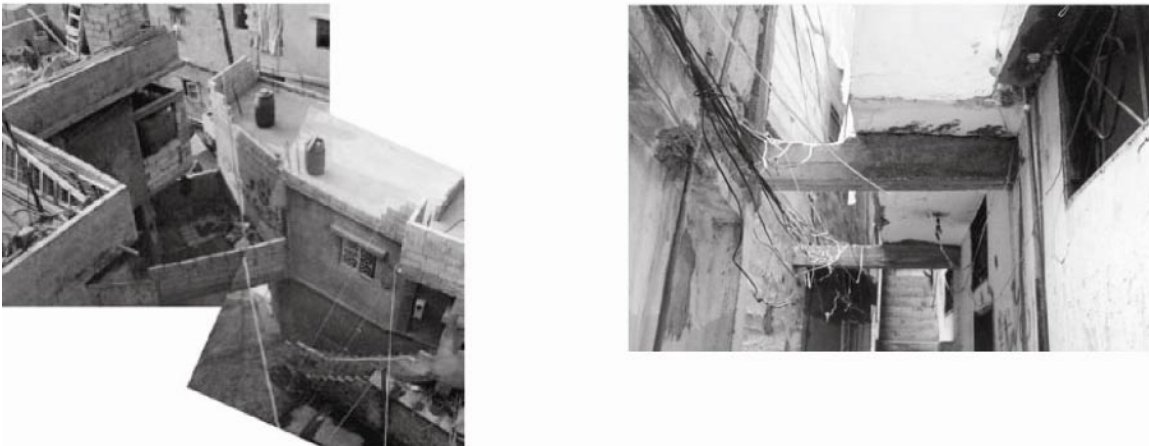
Figure 4.3: Interdependent structures. Images courtesy of Randa Ghattas

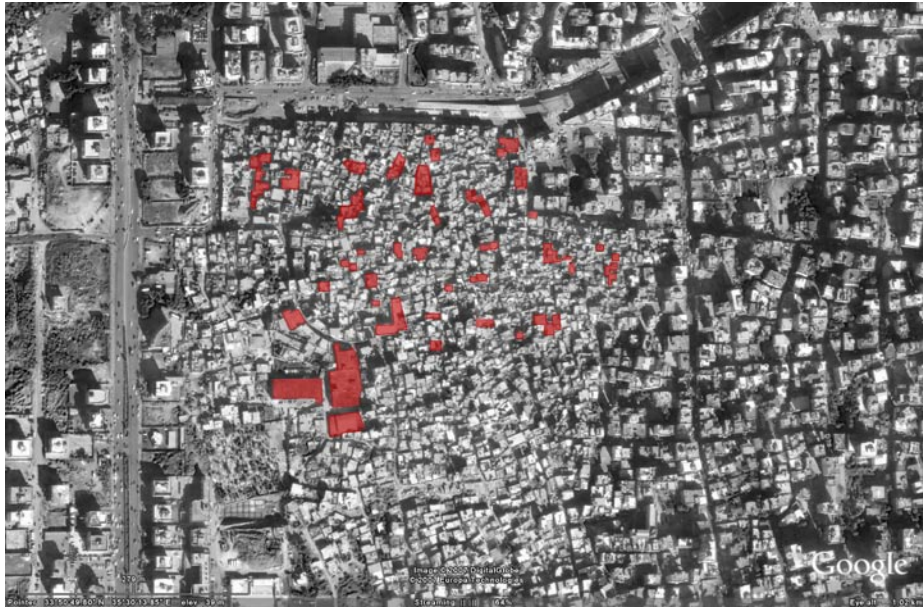
Figure 4.4: Scenario III-Phase 1: Determining usable structures.

buildings. Renovated buildings could be utilized as affordable housing, while new buildings will replace existing non-usable structures. The illustrations below show an aerial of Burj El Barajneh and the suggested stages of scenario III.

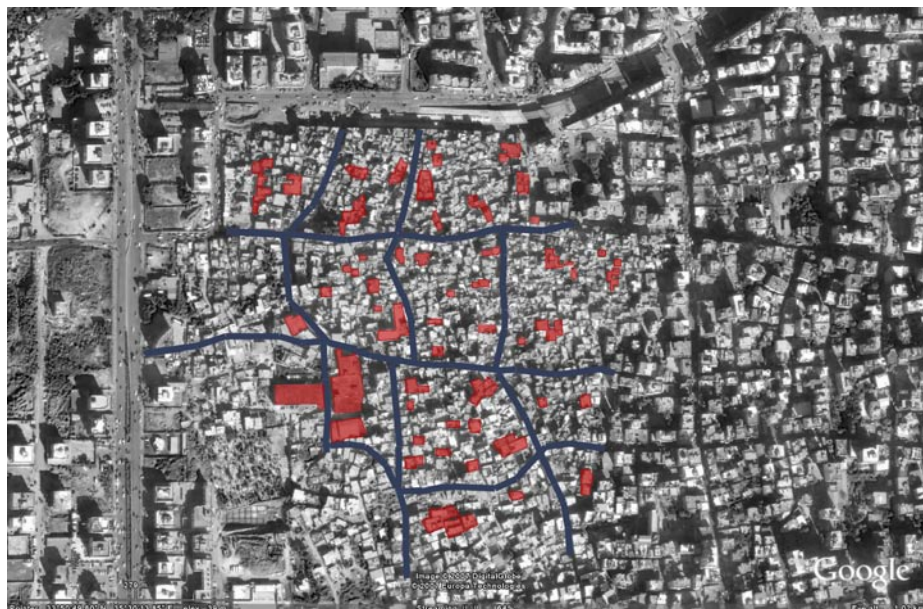
Figure 4.5: Scenario III-Phase 2: Determining main road routes

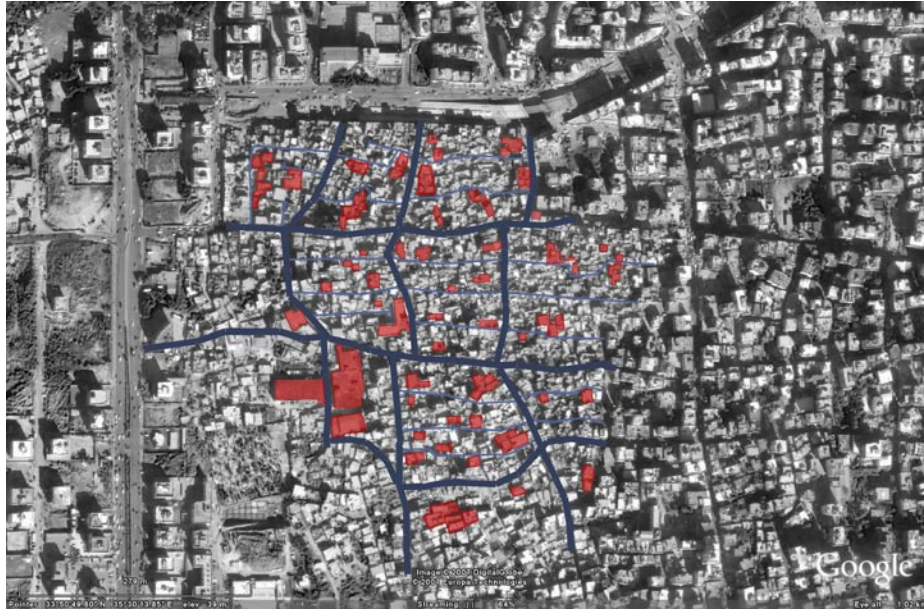
Figure 4.6: Scenario III-Phase 3 Providing access to all structures

El Barajneh shows, there is almost no uninhabited area in the camp large enough for such a facility (Figure 4.6). However, the facility could take advantage of the rooftop area of the public buildings in the camp owned by UNRWA, such as the hospital building and the UNRWA school building. These would provide a suitable location for the energy facility since they are in close proximity to one another, are located on the main road in the camp, and are beyond the reach of the public.

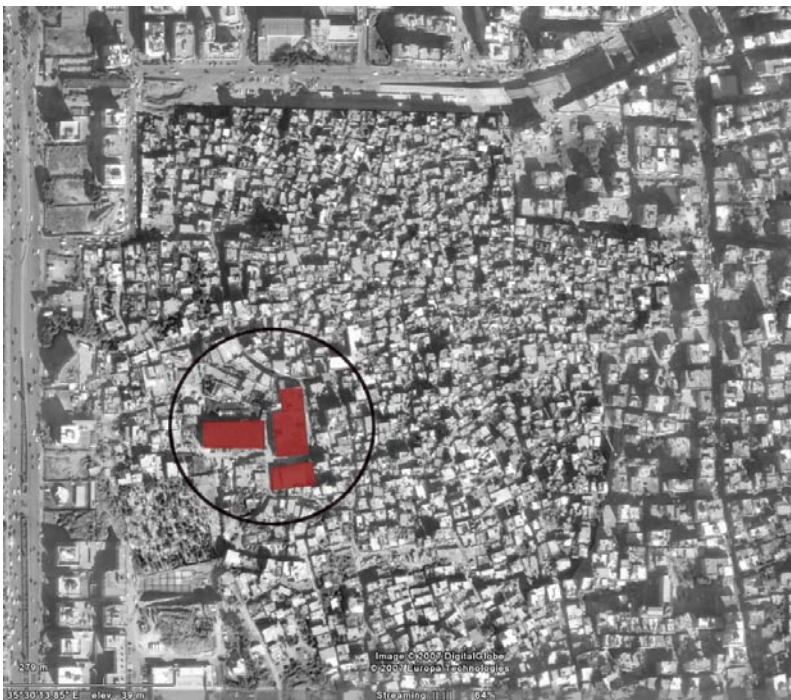
Figure 4.7: Suggested energy generation facility location

The calculations needed for the feasibility of such a facility in Burj El Barajneh were performed using a renewable-energy evaluation tool, RetScreen International, which utilizes climatic data, available technology information, capacity, and the area available for the facility, to calculate the final cost of the facility, its production capability and its efficiency within its estimated life span.
