CLINICAL DEVICE-RELATED ARTICLE

In vivo corrosion and damages in modular shoulder prostheses

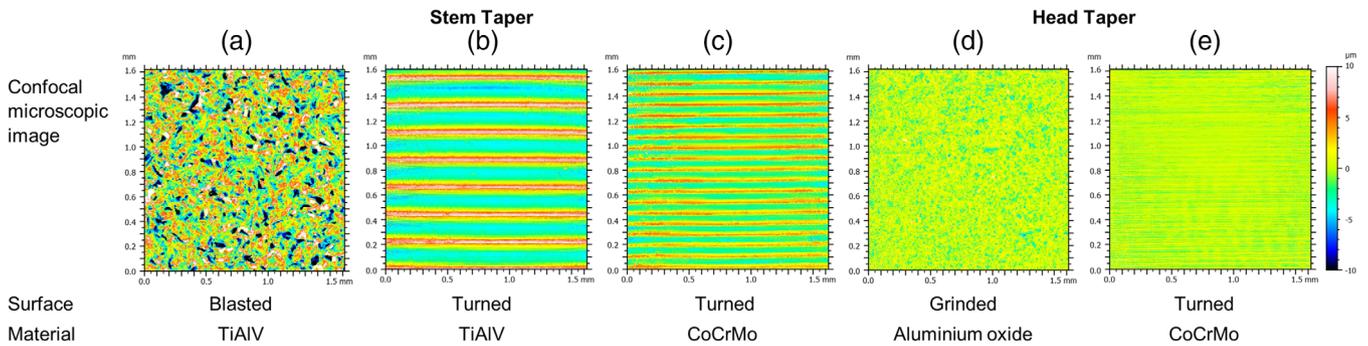
For a detailed characterization of the analyzed cohort, the topography of unloaded areas of all stem and head tapers was investigated using confocal microscopy. Figure 2 shows typical examples of different surface finishes at the taper. TiAlV alloy stem tapers show either an aperiodic profile due to corundum blasting (Figure 2a) or a periodic surface profile with machining marks from the turning process (Figure 2b), whereas CoCrMo alloy stems always exhibit periodic machining marks (Figure 2c). Humeral head tapers of sintered aluminum oxide ceramic were grinded with a diamond tool, which resulted in an aperiodic taper surface profile, and heads of CoCrMo alloy (Figure 2d) were machined by a turning process and exhibit periodic machining marks (Figure 2e).

FIGURE 2 Representative confocal microscopic images of stem and head tapers of unloaded areas that show different surface finishes (corundum blasted (a), turned (b,c,e) and sintered (d)) of the commonly used materials. The tapers are oriented in proximal (top) to distal (bottom) direction

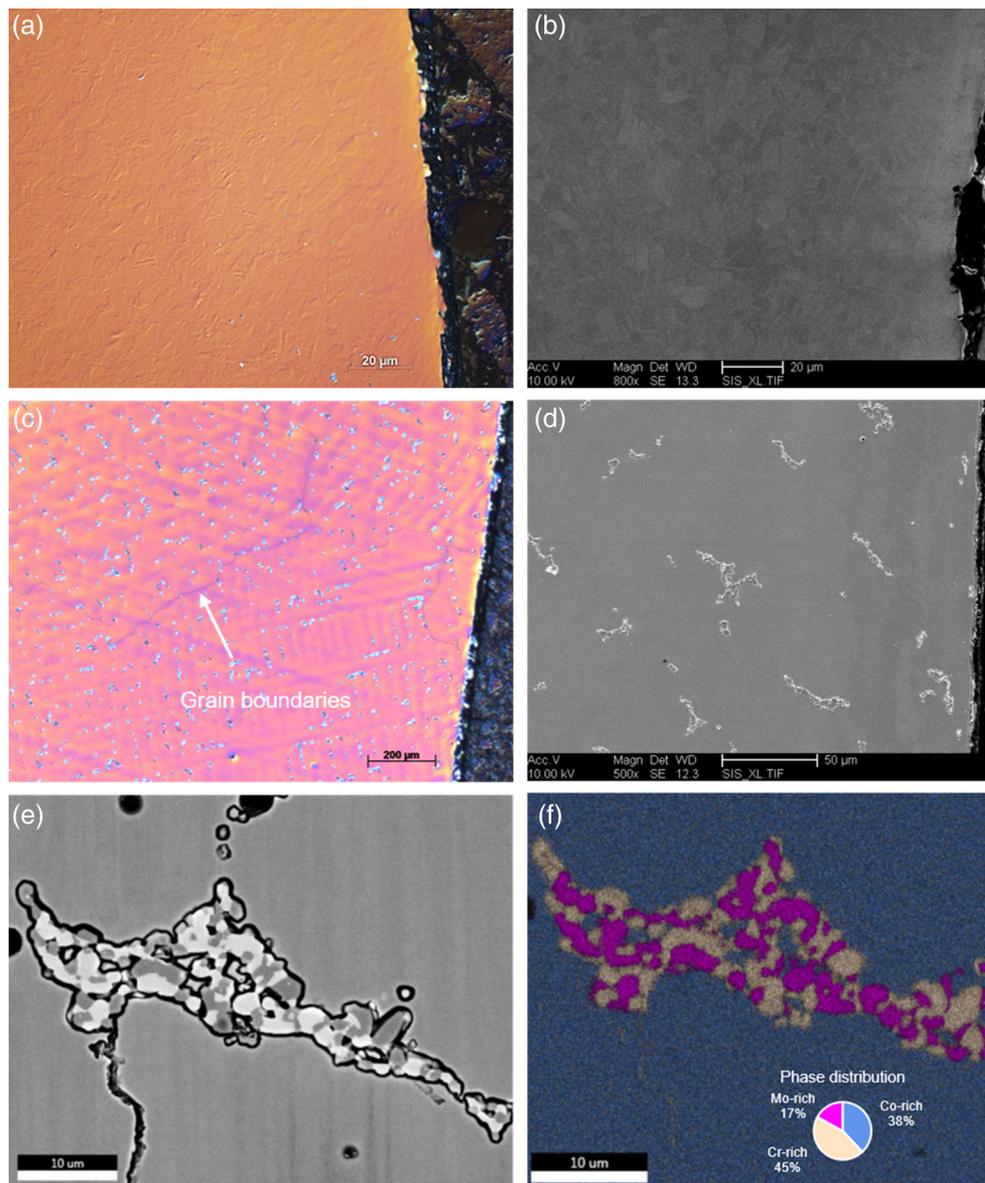
The investigated CoCrMo wrought alloy is fine-grained with grain sizes between 3 and 5 μm and shows an enhanced chemical homogeneity (Figure 3a,b). In contrast, CoCrMo cast alloys exhibit a typical dendritic microstructure and grain sizes in the scale of ~800 μm (Figure 3c,d). Moreover, an irregularly distributed secondary phase is visible which can be attributed to different characteristic hard phases (Jenko et al., 2018; Karpuschewski, Pieper, Krause, & Döring, 2013). Backscattered electron contrast images show them with grey scale differences that are associated with variances in the chemical composition (Figure 3e). This was verified in the EDS mapping that shows phases of increased chromium and molybdenum concentrations in comparison to the CoCrMo primary

**FIGURE 3** Optical microscopic images with polarizing filter (a,c) and SEM images of metallographic cross sections of different CoCrMo alloy heads. (a,b) Humeral head of CoCrMo wrought alloy (ASTM F1537, ISO 5832-12) exhibits small grain sizes in the order of 3–5 μ m and a homogeneous chemical composition. (c,d) Dendritic microstructure of a head of CoCrMo cast alloy (ASTM F75, ISO 5832-4) showing a secondary phase also along the grain boundaries. It is characterized by large grains (>800 μ m). (e) Backscattered electron contrast image of (c) with a higher magnification of the secondary phase and (f) the corresponding EDS mapping that demonstrates a heterogeneous chemical composition with deviating Cr-, Mo-, and Co-rich phases. All images are oriented from proximal (top) to distal (bottom) direction along the head taper counter

phase (Figure 3f). The process of chemical segregation occurs as the casting solidifies and results in characteristic carbon forming chromium carbides (Herrera et al., 2005; Weeton & Signorelli, 1954). Out of 24 humeral CoCrMo alloy heads, 12 were cast alloy

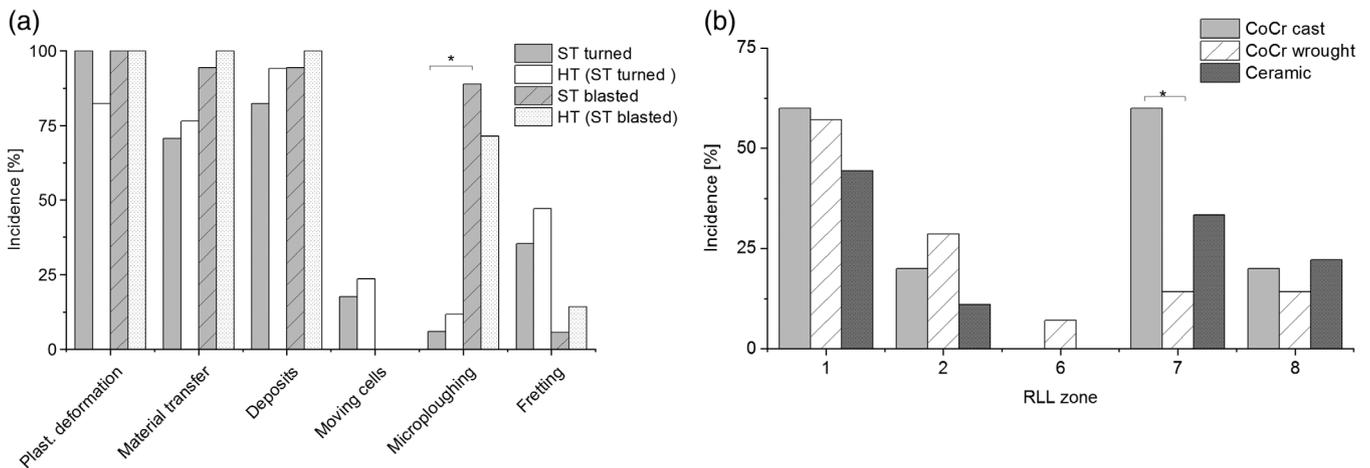
The incidence rates for the identified damage modes present in our cohort of anatomical shoulder tapers are summarized in Figure 8a. The most frequently observed damage modes are plastic deformation, material transfer and the formation of tribofilms and deposits with an incidence rate of more than 70% in our cohort. Their occurrence was independent of the material combination and taper surface finish. They originate from the alignment and in vivo loading

The main question was to determine whether a correlation exists between the assessed taper damage to the clinical data. Therefore, RLLs on preoperative radiographic images were assessed according to Sperling et al. (2000). They revealed that bone resorption occurs with an incidence rate of 62% in all our included patients (Figure S1). The results in Figure 8b demonstrate that RLLs are predominant in the proximal zones (1, 7, and 8) of the humerus independently to the

FIGURE 8 (a) Incidence rates of the identified damages and defects on stem tapers (ST) and head tapers (HT) according to the stem taper finish. The occurrence of microploughing shows a significant difference ($p = .0166$) between turned and blasted stems. (b) Results of the assessment of radiolucent lines (RLLs) in the humeral zones analyzed according to the modified Neer classification for different head materials. CoCrMo cast alloys show a significantly increased incidence for a RLL in the medial Zone 7 of the proximal humerus ($p = .0263$)
