A Research of Design in arid zones to
prevent flood problems.

**DESIGN PROPOSAL FOR A FLOODABLE PARK IN
CHAÑARAL, CHILE**

MASTER THESIS

Master of Landscape Architecture.
Hochschule Anhalt University of Applied Sciences.
Bernburg, Germany
06/2019

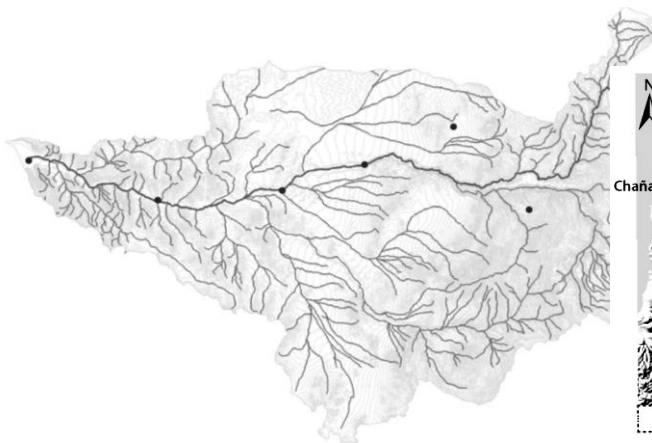
Figure 28: Chañaral rivers. Source: Angel Quiroz.

In Chañaral, the authorities have not worked on the river in terms of infrastructure either, so the edges of the river are natural land and the banks are not well defined for events such as floods. The streets that cross the river are of low quality and worsened the 25M disaster, since the space between walls is very small and if we add the extra material that the alluvium carried, it caused a collapse.

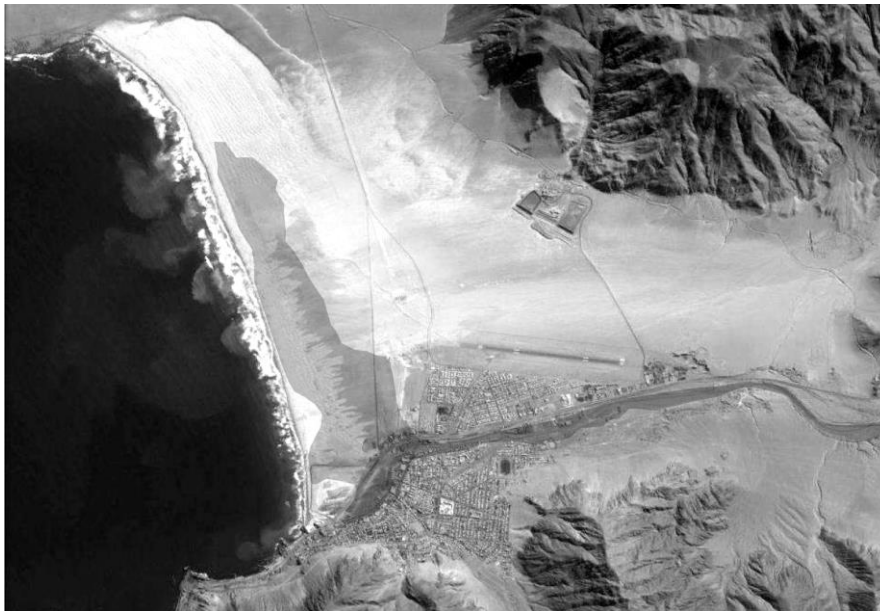
Figure 80: Satelital Picture with the flood. Own elaboration.

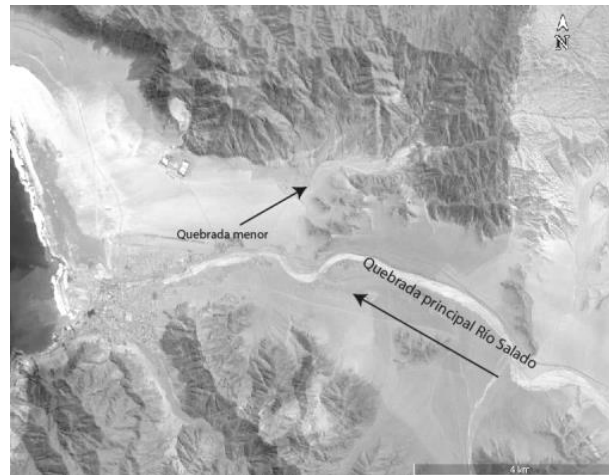
Figure 94: The Gullies in Chañaral next to the river. Source: Grijalba.

According to a study conducted by Chilean geologist Victor Grijalba, the flow of destruction reached an area of 2.75 km², with a north-south extension of 4 kilometers and east-west of 3.3 kilometers. There are differences in levels that caused an increase in the strength of the alluvium.

The different streams converge in a single river, the Salado, accentuating the water levels caused by the alluvium. If the river had a mouth in several points, the problem would have been not so serious. The impact it has is direct on the influence of the extent and deposits of the alluvium.

The soil is not very permeable and the large amount of exposed rocks were vital to aggravate the disaster.

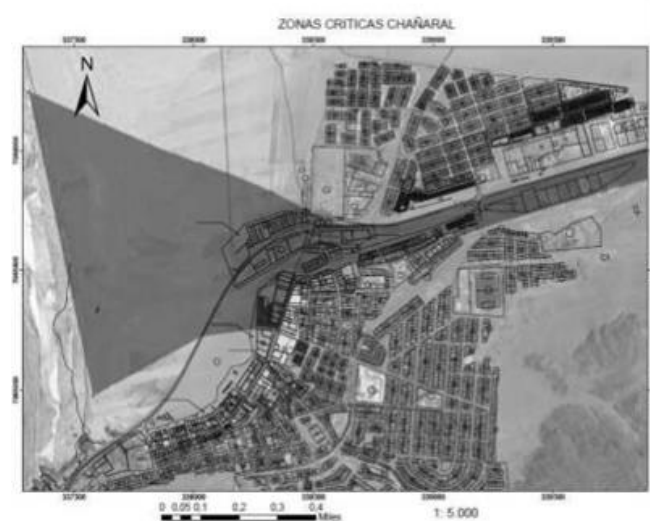
Figure 97: Map of critical zones in Chañaral. Source: Informe técnico det.zonas críticas localidades afectadas por fenómeno hidrometeorológico 24, 25, 26 y 27 de marzo. Comisión interministerial ciudad, vivienda y territorio. Chile.

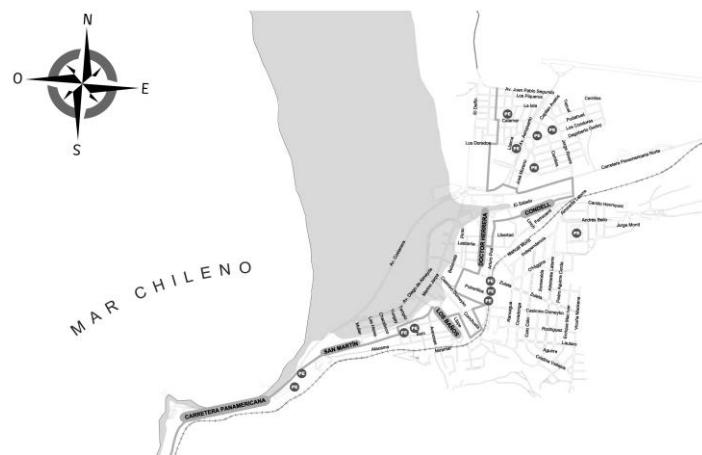
Figure 99: The map that shows the safety zones as a green line. The blue dots means meeting points. This map was done by ONEMI in 2001.

The ONEMI³¹, an organism of the government for emergencies made zones of protection for eventual tsunamis and floods. The design of this zones is based on the worst disaster of the place, in 1922, a tsunami with an earthquake. They considerate the topography of the place.

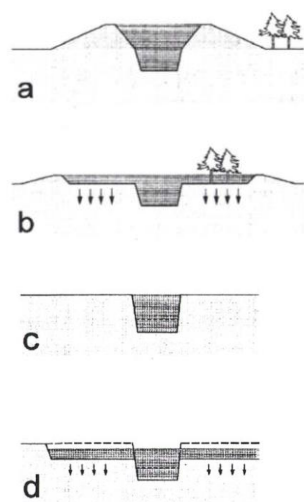
Figure 126: Flood containment. Source: El Río y la Forma. 2009.

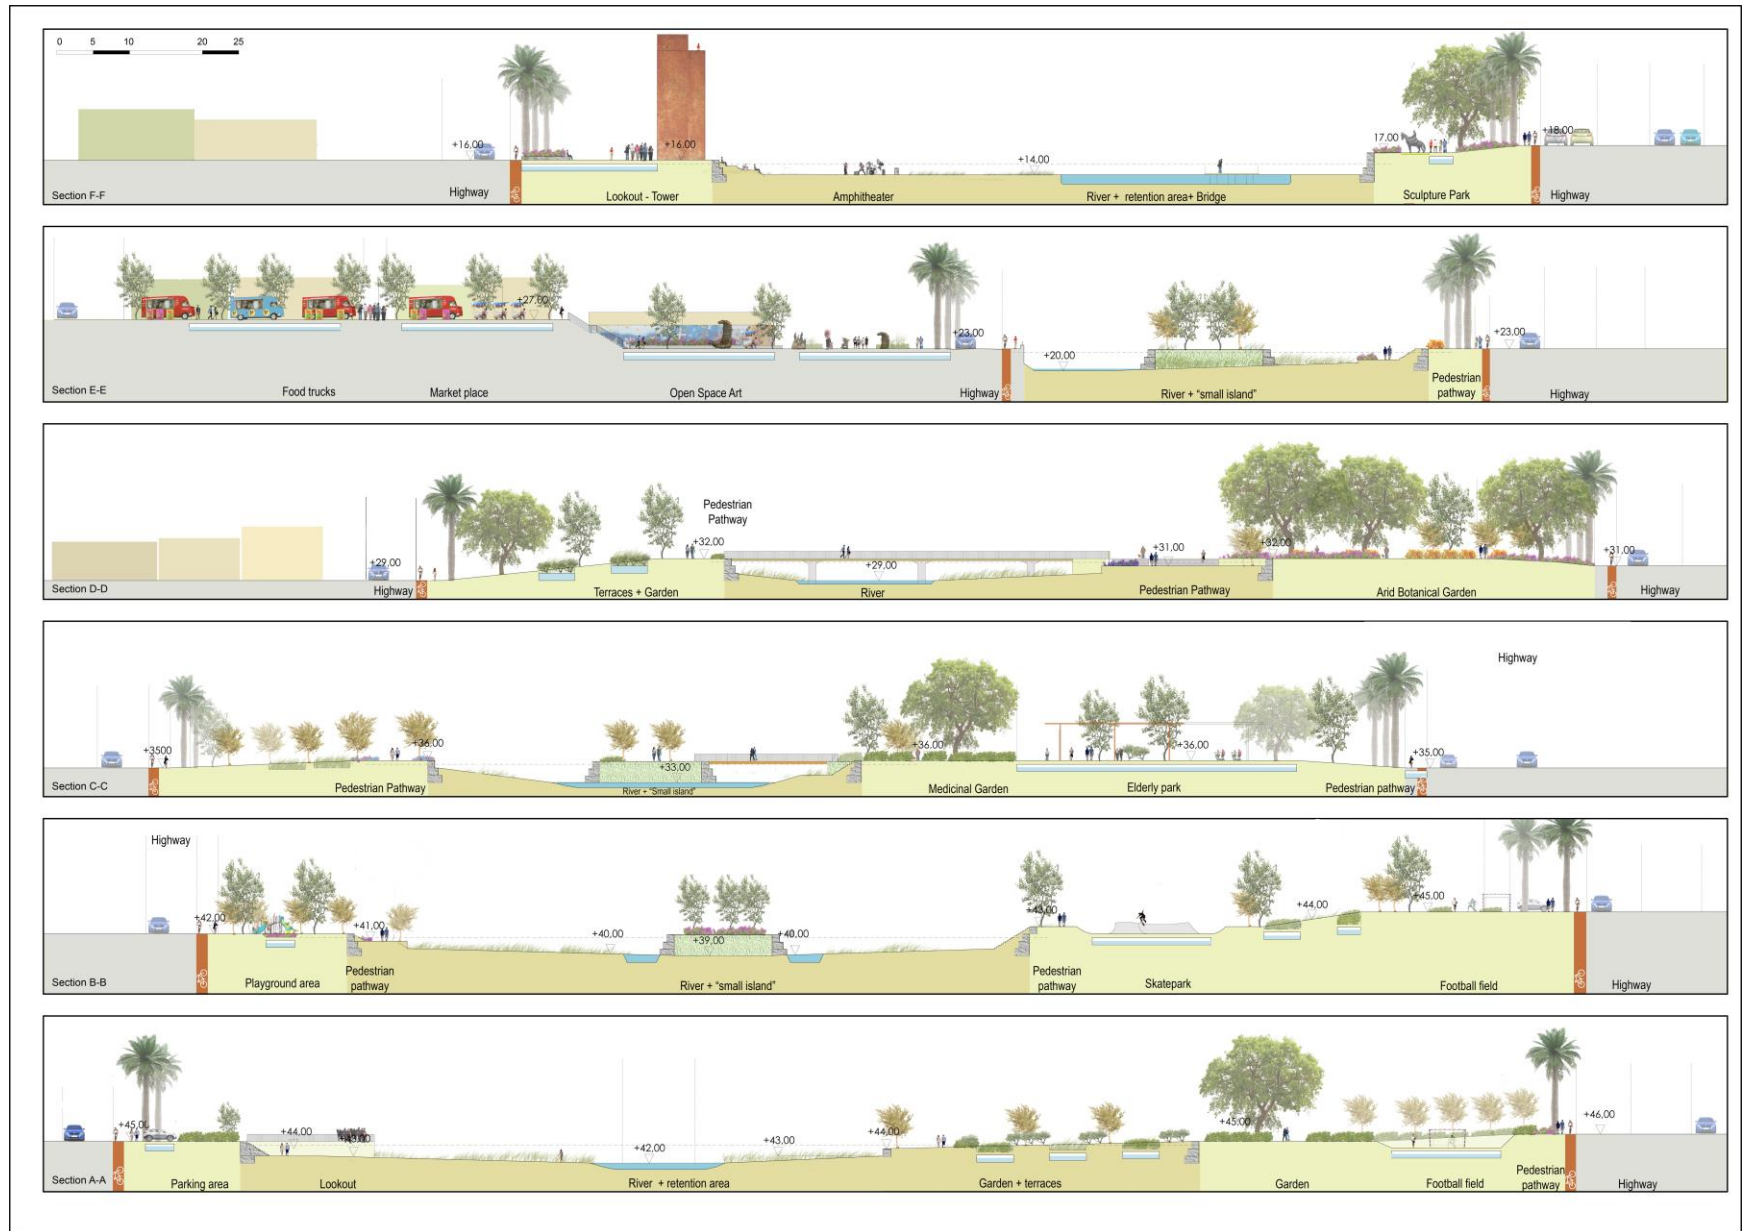
Figure 153: Sections. Own elaboration.

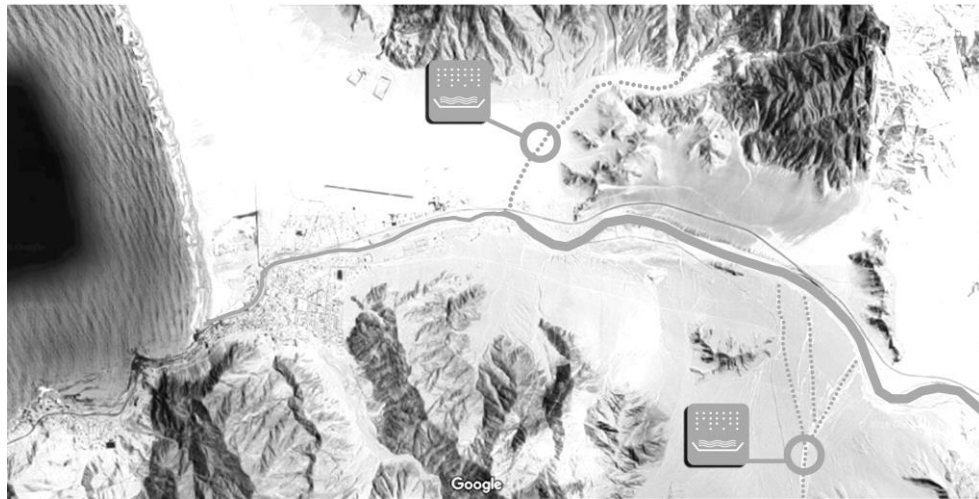
Figure 163:Retention zones. Own elaboration.

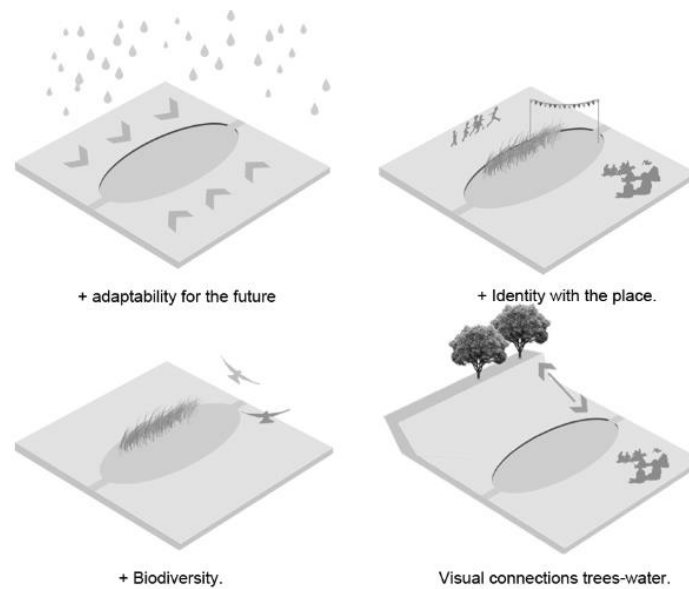
Figure 165: Benefits of retention zones.

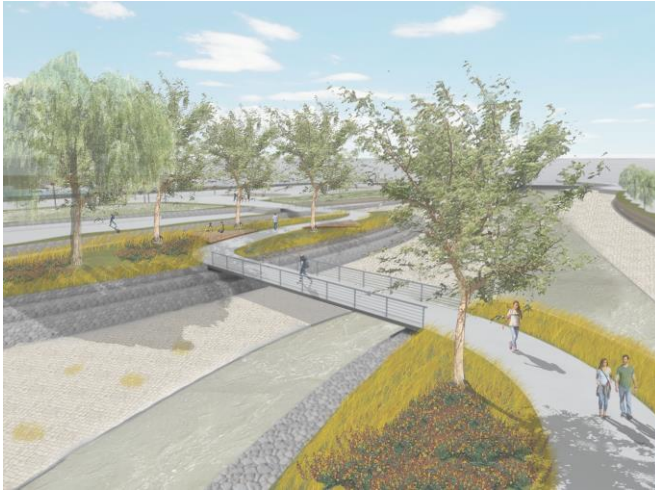
Figure 175: The islands. Normal situation. Own elaboration.

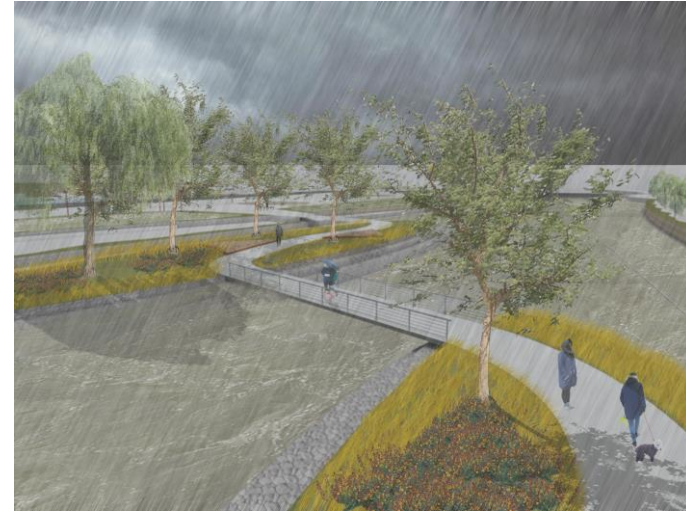
Figure 176: The Island. Raining season. Own elaboration.
